INNOVATIVE FRP PILING REPAIR WITHOUT THE USE OF COFFER DAMS

Steve Bazinet, Larry Cercone, Franz Worth
Air Logistics Corporation
Field-Applied Composite Systems Group
Pasadena, California 91107

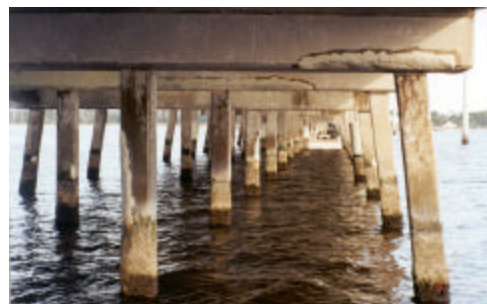
Figure 2. Concrete deterioration

Steel reinforced concrete bridge and pier pilings are subject to splash zone damage in both fresh and salt water areas (Figure 2). The damage to the concrete is usually caused by abrasion or impacts by wave and tidal action, collisions with marine vessels, and normal spalling. In addition, oxygen and water penetration can cause corrosion of the reinforcing steel.

When this happens, the resulting expansion causes the concrete to fracture. The corrosion of steel in these structures is exacerbated in the splash zone due to the combination of salt-water and oxygen present in this area of the piling. The damage to the pilings may be cosmetic or structural. In either case, the repair system must restore the piling and reduce further deterioration.

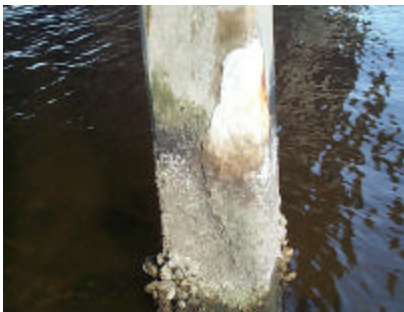
Figure 3. Typical Repair Situation

Restoration of splash zone damage to steel reinforced concrete pilings (Figure 3) has traditionally been accomplished by a variety of techniques. These include concrete encapsulation using steel or composite forms (Figure 4), wrapping with traditional composite systems, or simply patching the spalled concrete. The first two systems can be used for repairing cosmetic damage as well as structural damage (1). Patching is limited to cosmetic repairs only. Concrete patching materials do not work well in splash zone situations or in geographical areas subject to freeze thaw conditions. These environmental factors cause insufficient bonding to the base concrete which will result in premature failure of the repair. While encapsulation systems can be used without the use of coffer dams they are complicated and difficult to deal with (2). Conventional field-saturated composite systems using epoxy require that saturation equipment be brought on-site and that a highly trained staff perform the installation. This type of repair is generally not an environmentally friendly process either. This type of installation certainly requires the use of a coffer dam. The use of a water activated repair system avoids these difficulties. This type of system is moisture activated and cures normally when applied underwater or in the splash zone. The system can be installed at low tide with scaffolds or by divers in deeper water, thus eliminating the need for expensive coffer dams and the extended time necessary to complete the repair.
